## PD measurement saves refinery millions

Alexander Lüpschen - Asset Consulting Engineer,  
Koopmann Energie und Elektrotechnik

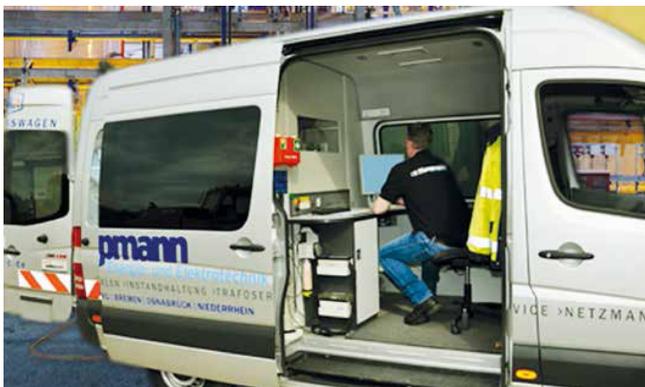
The central Centrix control unit means that tests can be carried out in quick succession
